BERTHOUD NEIGHBORHOOD (GREEN BRIDGE) LITTLE THOMPSON RIVER FLOODPLAIN REHABILITATION

Weekly Construction Notes

Date: 03 January 2018

Location: Green Bridge Site on the Little Thompson River

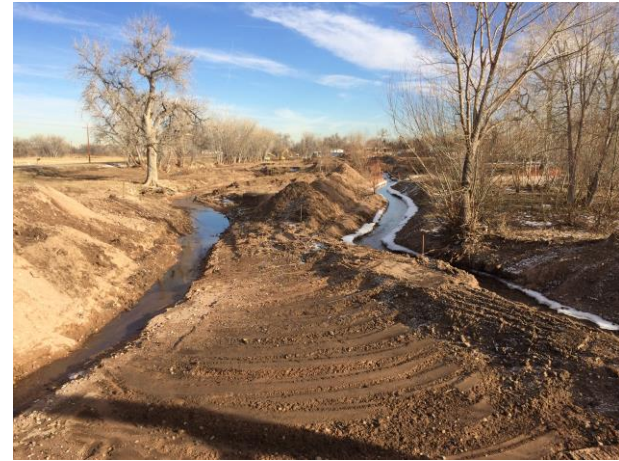
*Figure 1 – Standing on Green Bridge looking east.
The main channel is on the left, the diversion channel is on the right.*

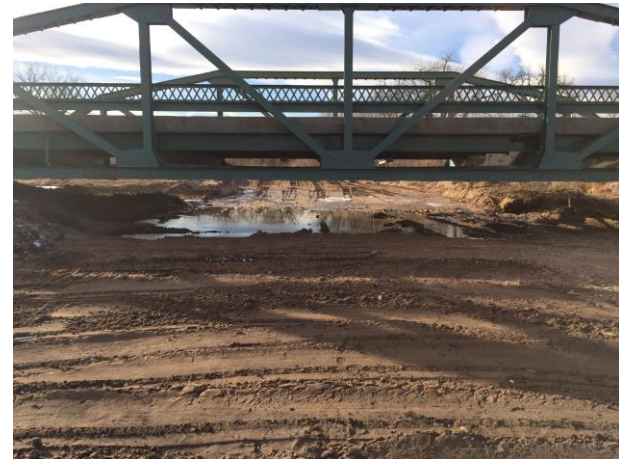
*Figure 2 – Looking west at completed sediment removal under
Green Bridge. Diversion channel runs to the left of this photo.*
