BERTHOUD NEIGHBORHOOD (GREEN BRIDGE) LITTLE THOMPSON RIVER FLOODPLAIN REHABILITATION

Weekly Construction Notes

Date: 17 January 2017

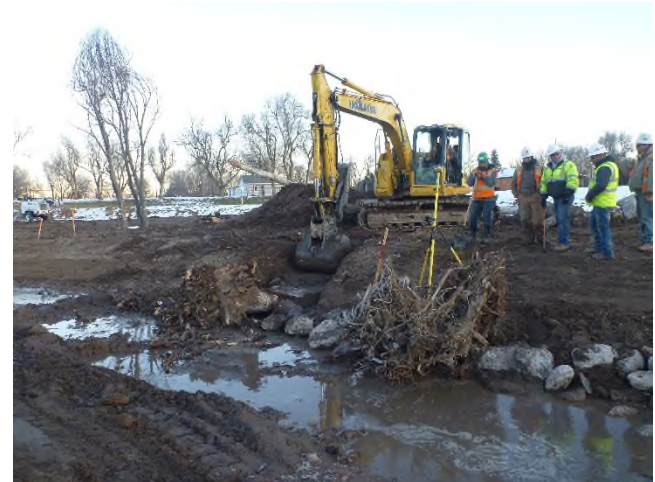
Figure 1 – Looking downstream near Sta 1+00 at rootwad installation on right bank. Final channel grading via placement of design channel bed material has not yet been completed.

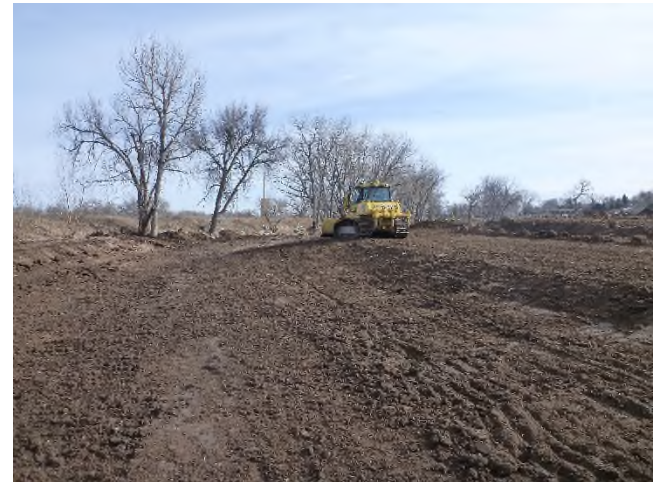
Figure 2 – Looking downstream at coarse channel grading near Sta 11+00. Final channel grading via placement of design channel bed material has not yet been completed.
