# BERTHOUD NEIGHBORHOOD (GREEN BRIDGE) LITTLE THOMPSON RIVER FLOODPLAIN REHABILITATION

## Weekly Construction Notes

**Date:** 24 January 2017

**Location:** Green Bridge Site on the Little Thompson River

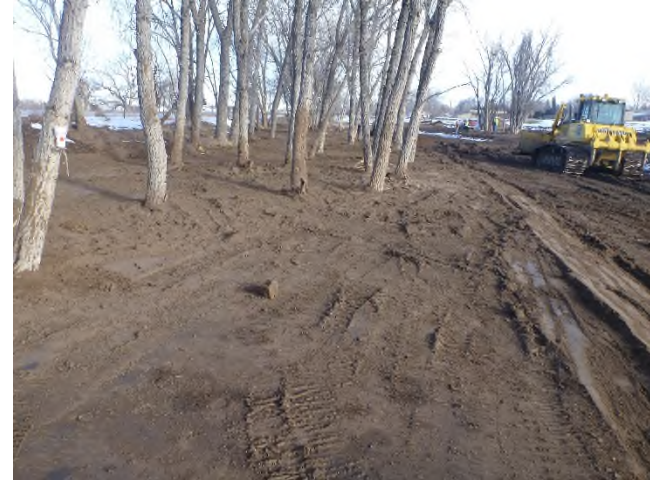
Figure 1 – Looking downstream near Sta 7+00 at the floodplain grading in the gallery zone on the left bank. Coarse channel grading is underway at right.

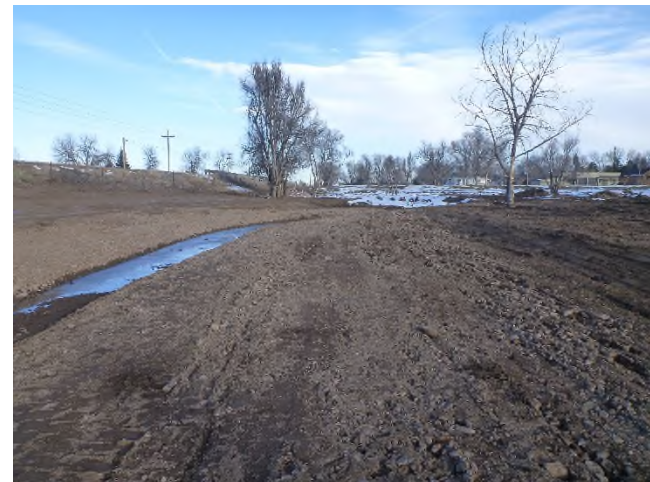
Figure 2 – Looking downstream at fine channel grading near Sta 4+00. Design channel bed material has been placed.
