# BERTHOUD NEIGHBORHOOD (GREEN BRIDGE) LITTLE THOMPSON RIVER FLOODPLAIN REHABILITATION

## Weekly Construction Notes

**Date:** 31 January 2017

**Project Sponsor:** Little Thompson Watershed Coalition

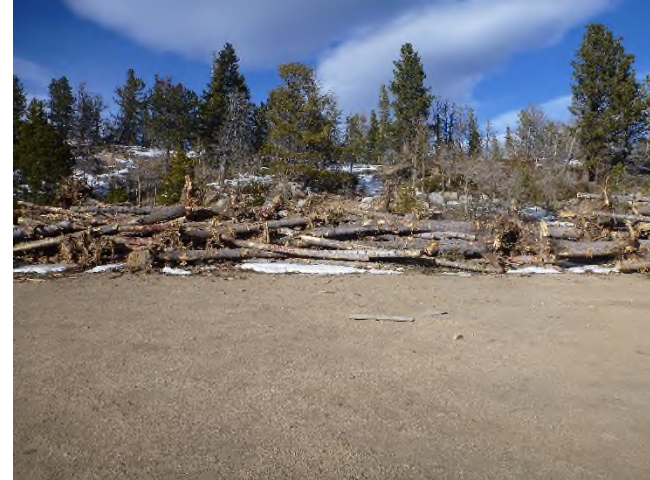
*Figure 1 – Available rootwads located near Ward, CO that meet the design specification. AWC will send an excavator and trucks to retrieve and stockpile at the site.*

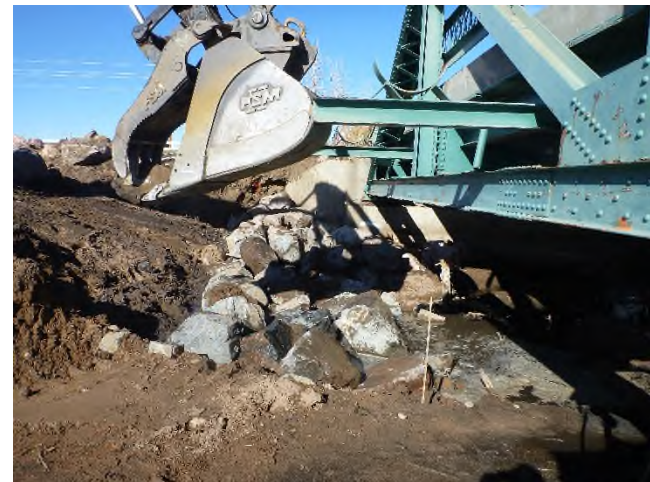
*Figure 2 – Stacked boulder wall being constructed around the Green Bridge. (Photo taken from the upstream side of the bridge looking north.)*

1. Onsite material sorting for design gradations is complete with approximately 2,100 CY created.
2. Coarse channel grading is complete up to Sta 24+50.
3. Fine channel grading with bed material to include riffles and pools is complete up to Sta 9+25.
4. Gallery zone floodplain grading on the left bank from Sta 17+00 up to Sta 22+00 is underway.
5. Rootwad retrieval and stockpiling.
6. Stacked boulder protection around the Green Bridge.
7. Willow stakes are underway beginning downstream.
