# BERTHOUD NEIGHBORHOOD (GREEN BRIDGE) LITTLE THOMPSON RIVER FLOODPLAIN REHABILITATION

## Weekly Construction Notes

**Date:** 7 February 2017

**Location:** Green Bridge Site on the Little Thompson River

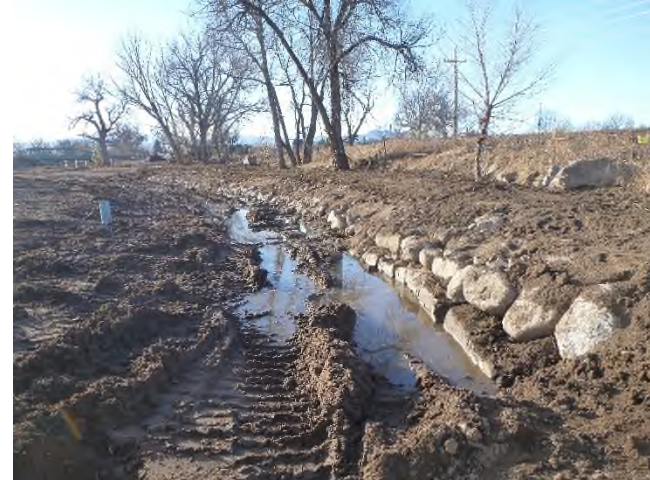
*Figure 1 – Looking upstream at the newly completed stacked boulder bank at Sta 10+00. The channel will be constructed out of the design bed material up to the top face of the toe boulders.*

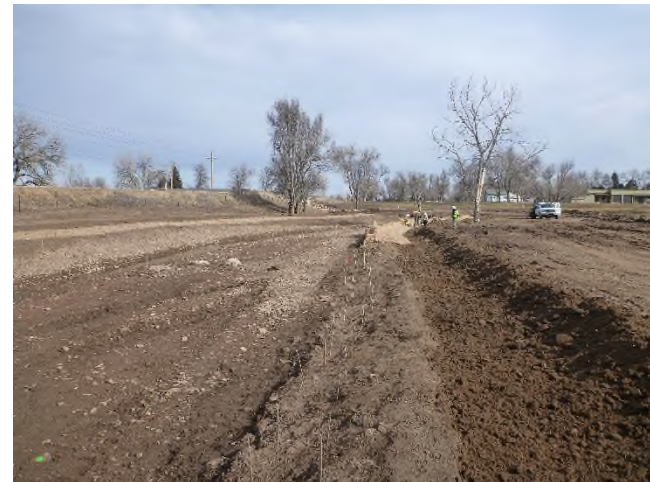
*Figure 2 – Looking downstream near Sta 4+50 at the erosion control blanket and willows being installed. A boulder cluster is visible on the head of the point bar near the low flow channel.*
