BERTHOUD NEIGHBORHOOD (GREEN BRIDGE) LITTLE THOMPSON RIVER FLOODPLAIN REHABILITATION

Weekly Construction Notes

Date: 14 February 2017

Location: Green Bridge Site on the Little Thompson River

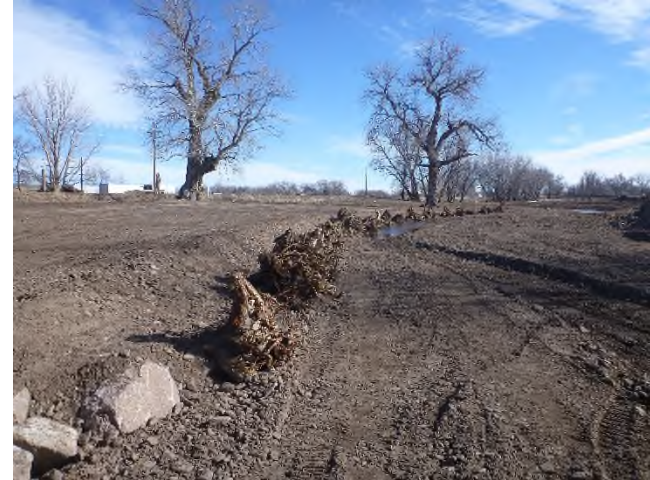
Figure 1 – Looking downstream near Sta 15+00 at the final channel shaping with design bed material. Completed rootwads are visible at left.

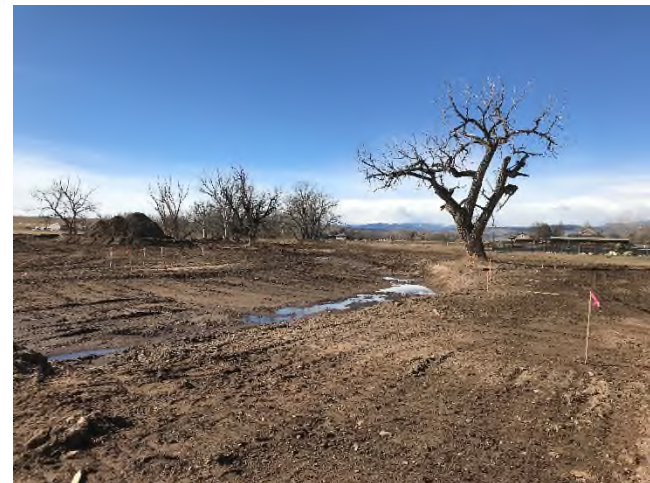
Figure 2 – Looking upstream near Sta 21+00 at the coarse channel grading. Channel bed material and final channel shaping has not yet occurred. Ground water seepage visible.
