# BERTHOUD NEIGHBORHOOD (GREEN BRIDGE) LITTLE THOMPSON RIVER FLOODPLAIN REHABILITATION

## Weekly Construction Notes

**Date:** 10 January 2017

**Location:** Green Bridge Site on the Little Thompson River

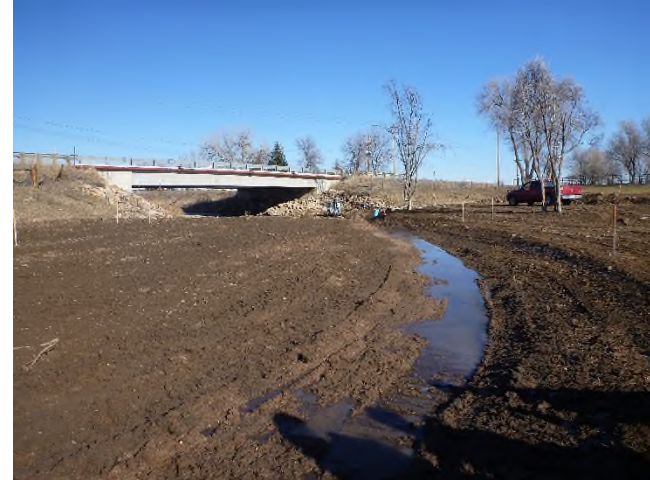
*Figure 1 – Looking downstream at Sta 2+00 at coarse channel grading before low flow channel and pool are shaped. Rootwads will be installed on right bank. CR4 Bridge in the background.*

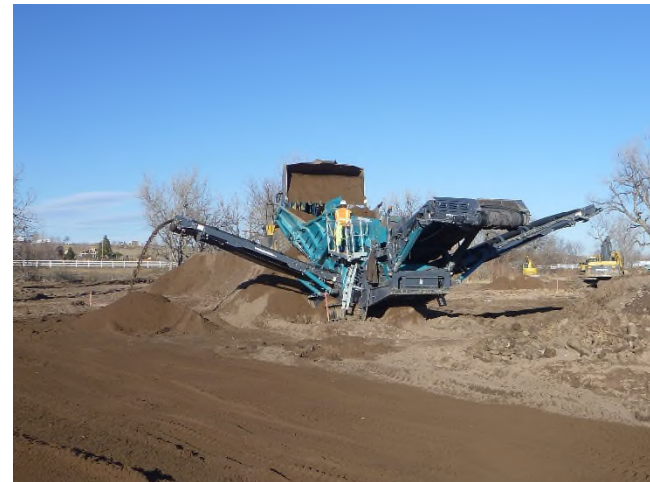
*Figure 2 – Looking North across the floodplain as channel bed material is sorted via a power screen and stockpiled for later use to shape the in-channel riffles and pools.*
