BERTHOUD NEIGHBORHOOD (GREEN BRIDGE) LITTLE THOMPSON RIVER FLOODPLAIN REHABILITATION

Weekly Construction Notes

Date: 28 February 2017

Location: Green Bridge Site on the Little Thompson River

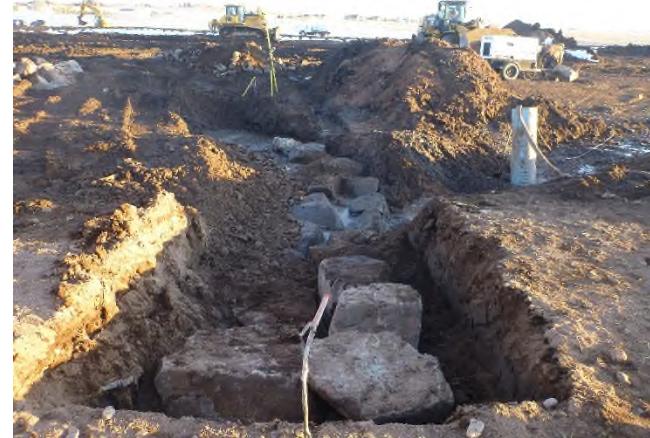
Figure 1 – Looking South across the channel at approximately Sta 22+50 at the at-grade boulder structure under construction.

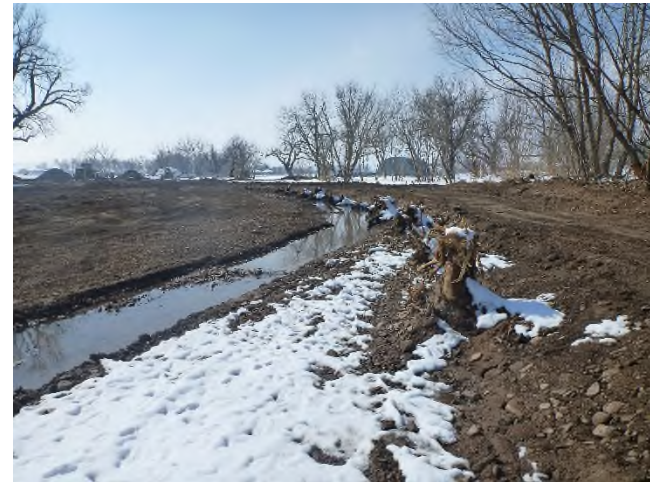
Figure 2 – Looking upstream from Sta 17+00 at the recently completed rootwad revetment on the left bank (photo right).
